Manhole Inspection Summary

Manhole # S35II1016MH

Insp Date: **1/22/07 2:51 PM**

Location Address: **220 WENDOVER RD**

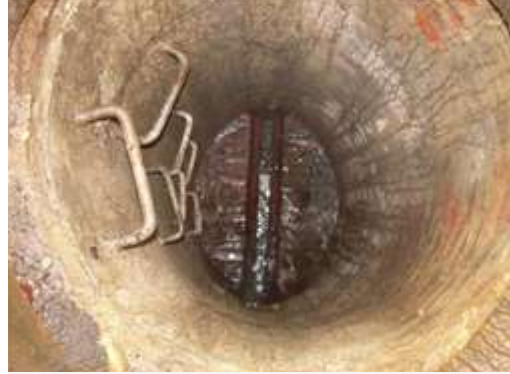
Top View

Bench ☒ Exists Material: **Brick** ☐ Parged ☒ **Debris** (not Condition related)

Bench debris.

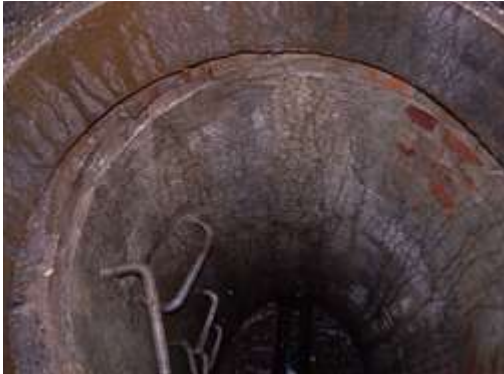
Defect

Frame Offset: **2** (in.) Condition: ☐ Sound ☐ Cracked ☒ **Leaks**

Condition: ☐ Sound ☐ Cracked ☐ Root Intrusion ☐ Loose Brick ☒ **Deteriorated**

Infiltration: ☐ None ☒ **Joint** ☐ Cracks ☐ Mortar ☐ Roots ☒ **Wall**

Infiltration: ☐ None ☐ Joint ☐ Cracks ☐ Mortar ☐ Roots ☒ **Wall**

Frame leaks. Frame offset. Adjustment deterioration and infiltration. Corbel and Barrel infiltration.

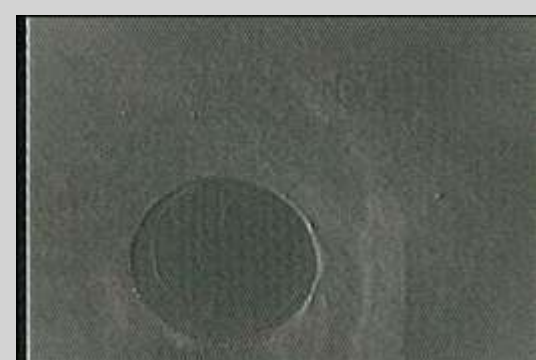
8 in. Circular Gravity Sewer Pipe In @ 6 O'Clock

Invert Depth: **8.22** (ft.) Flow Characteristics: **Slow**

Infiltration: **None** Pipe Seal Cond: **Unknown**

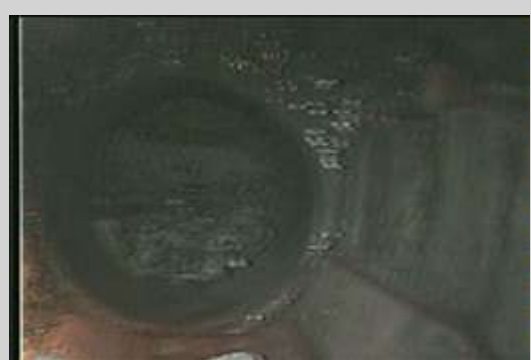
Drop In @ 6 O'Clock

Drop: **Outside** Rod and Bar

Drop Condition: **Clogged**
